Foliar Salt Damage of Landscape Plants Induced by Sprinkler Irrigation

S. Miyamoto
and
John M. White

Synopsis

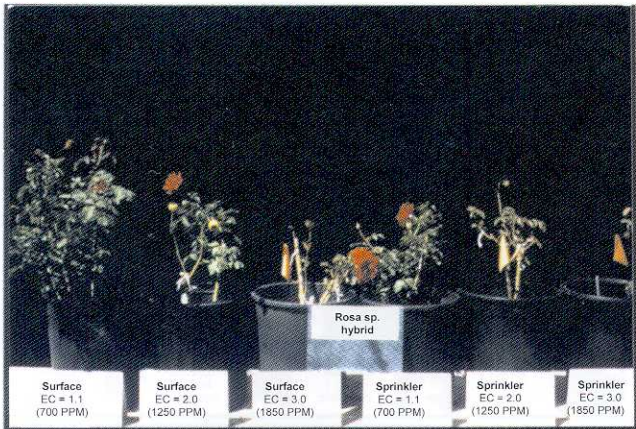
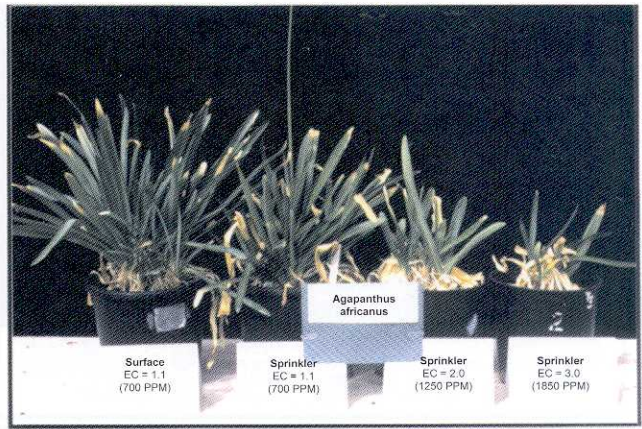
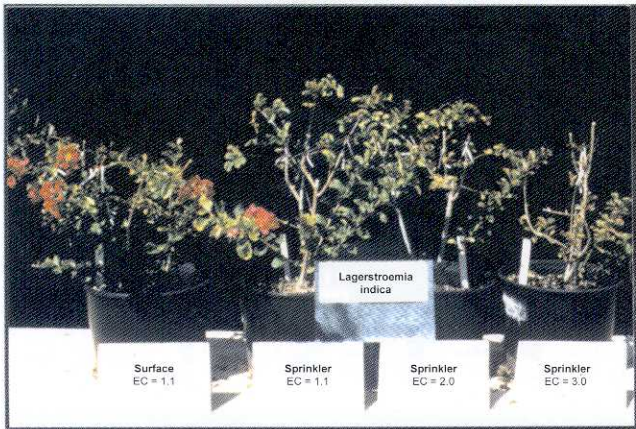
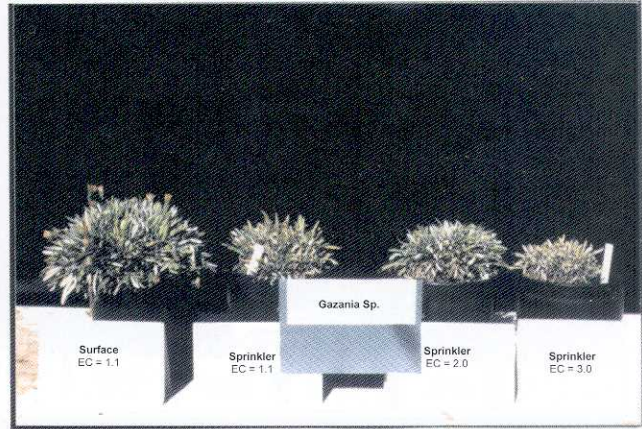
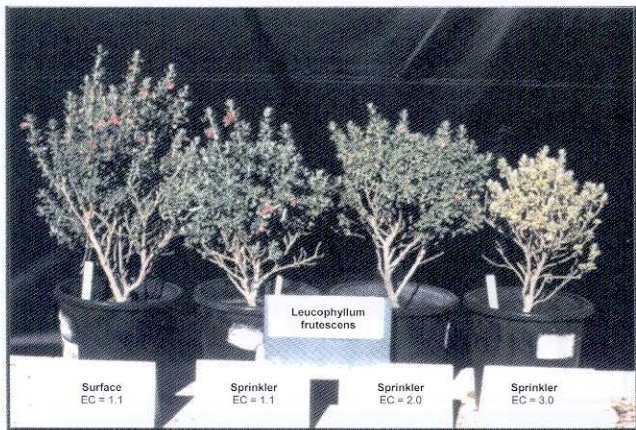
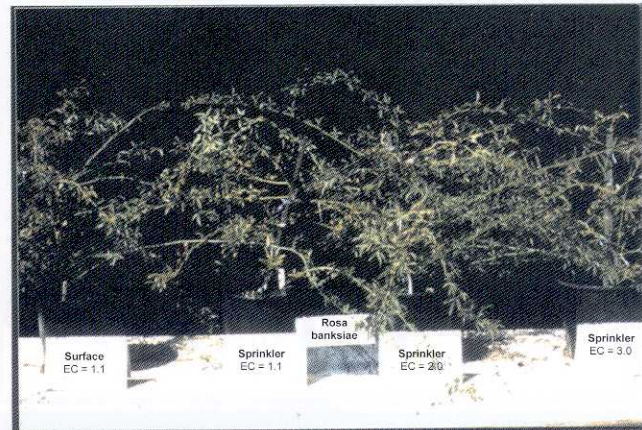
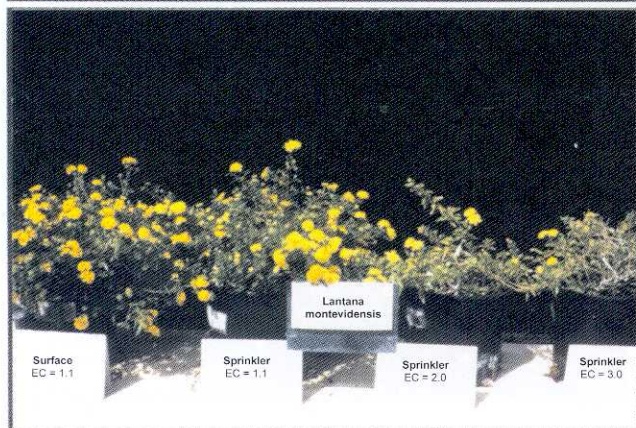
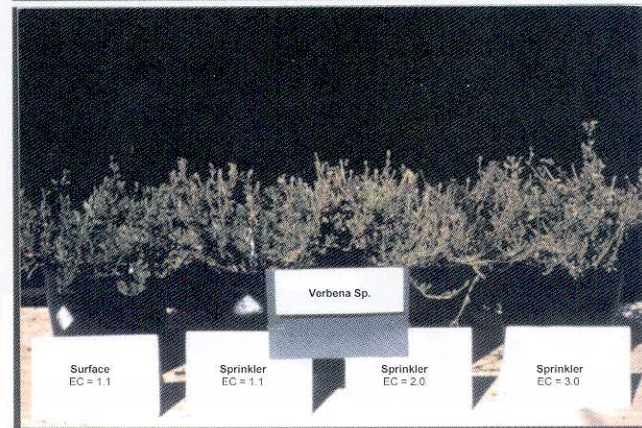
Photo Set 1. Flowering Perennials and Shrubs

Flowering plants irrigated with tap water grew almost twice the initial size of the plants during the test period of March 25 through September 25. However, plant growth, evaluated by the relative shoot growth (Table 2), was reduced with increasing salinity, especially in Tea Rose, Lily of the Nile, Crape Myrtle and Gazania. The growth of Texas Sage, Climbing Rose, and Lantana was also reduced significantly when sprinkled with 3.0 dS m⁻¹ water (or 1850 ppm). When grown under surface irrigation, Tea Rose grew better than those under sprinklers. Lantana, Verbena, and Indian Hawthorne (listed under a category "shrubs") were more tolerant to salts than the other flowering plants tested (Photo Set 1).

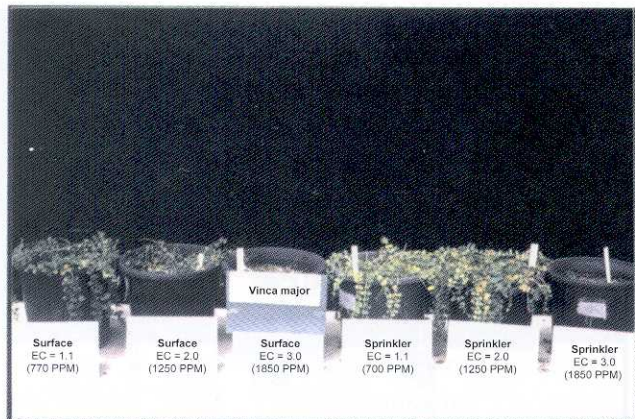
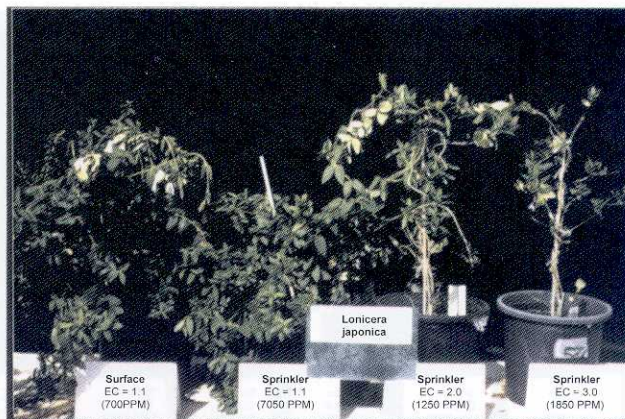
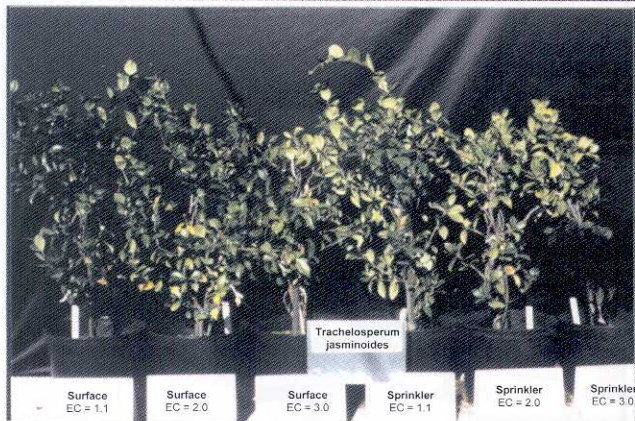
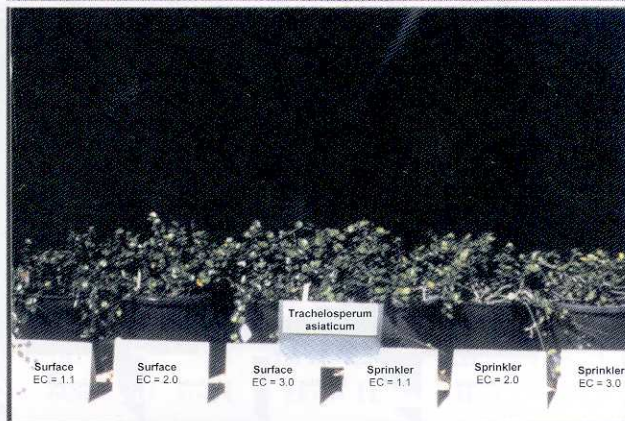
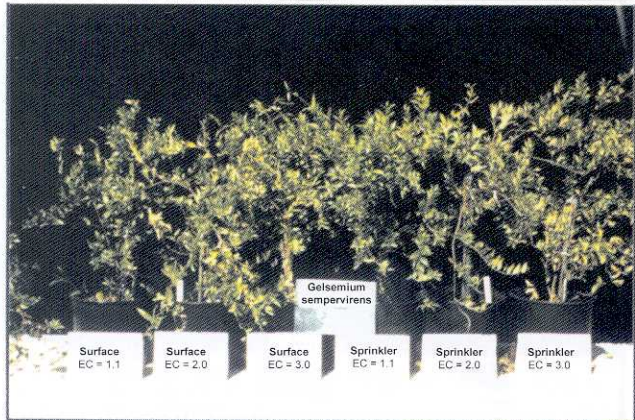
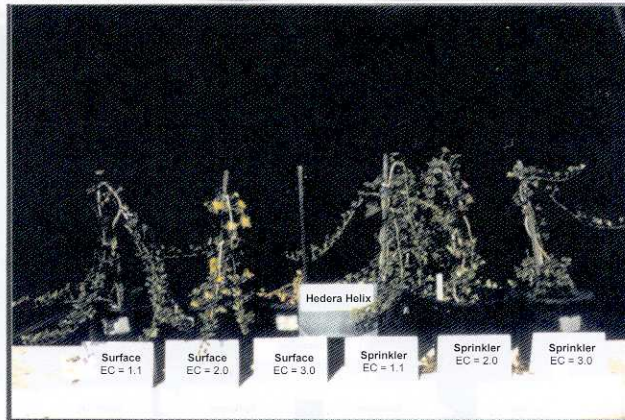
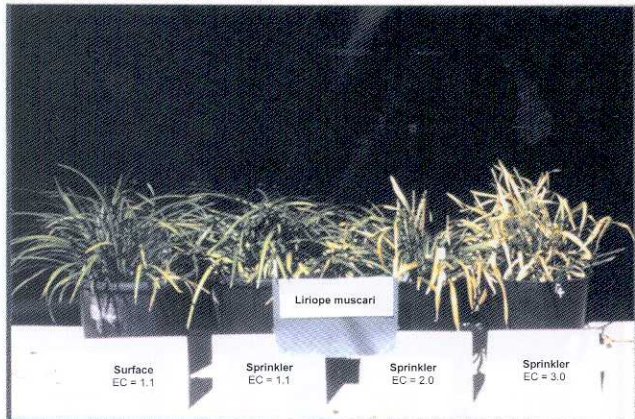
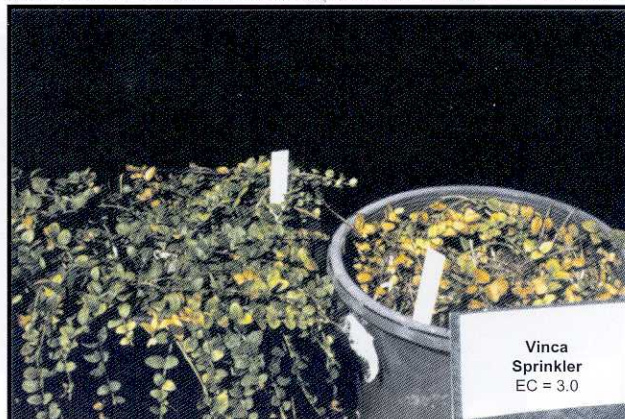
Photo Set 2. Vines and Ground Covers

times of the initial size when irrigated with the tap water. Vinca was found exceptionally sensitive to salts, and its leaves were desiccated in a month when sprinkled with 3.0 dS m^{-1} (Photo Set 2). Honeysuckle and Star Jasmine experienced a significant growth reduction when sprinkled with 2.0 dS m^{-1} water, whereas Carolina Jasmine, English Ivy and Liriope tolerated sprinkler irrigation with 2.0 dS m^{-1} water. (Both Jasmines and English Ivy are known to experience a significant growth reduction when surface-irrigated at 2.0 dS m^{-1} , but not Carolina Jasmine). Growth of Liriope plants was unaffected by sprinkling of 3.0 dS m^{-1} water, but it suffered extensive leaf injuries toward the end of the growing season.

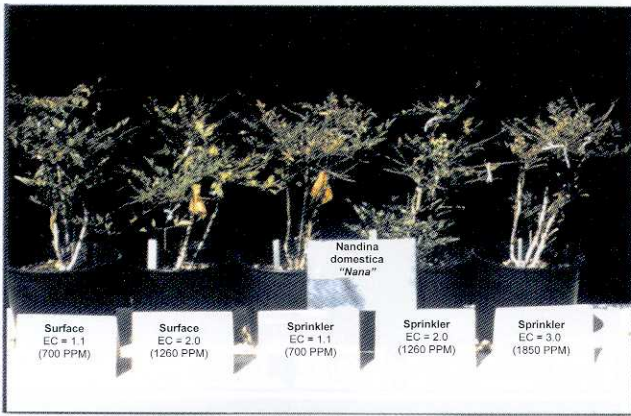
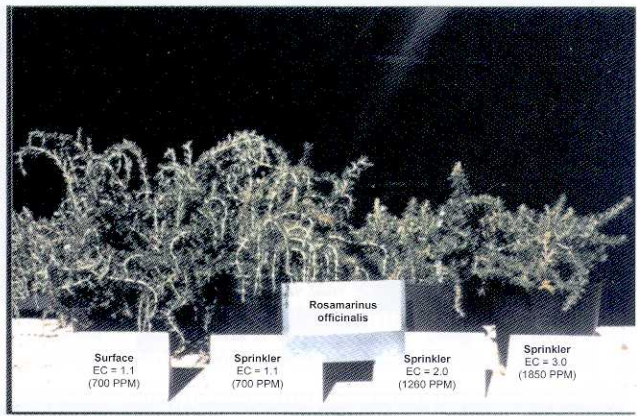
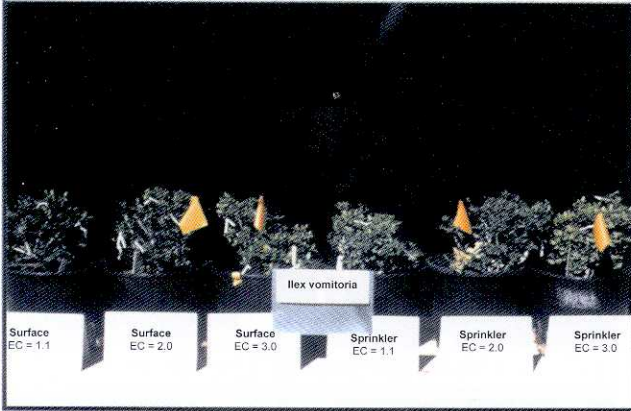
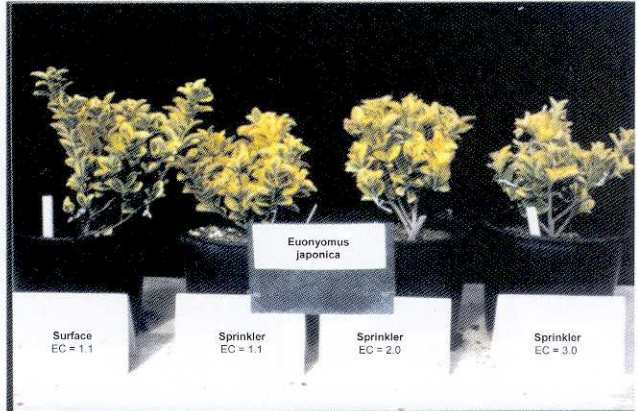
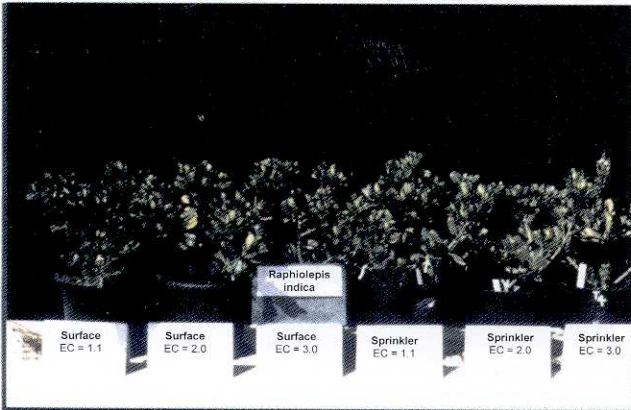
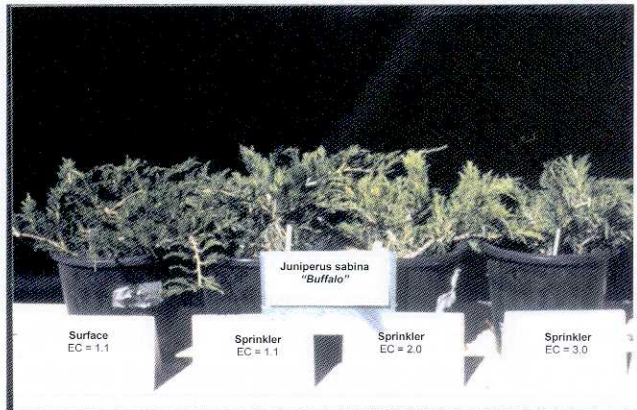
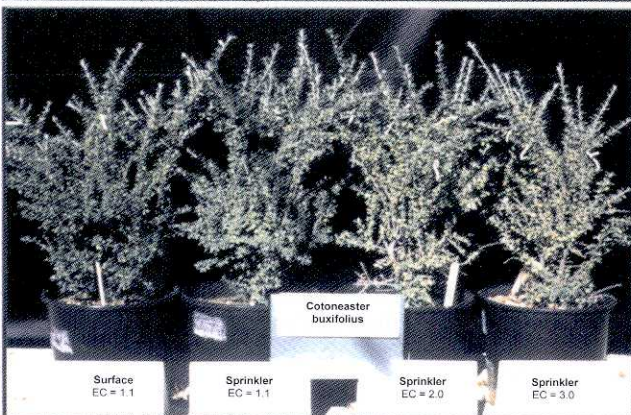
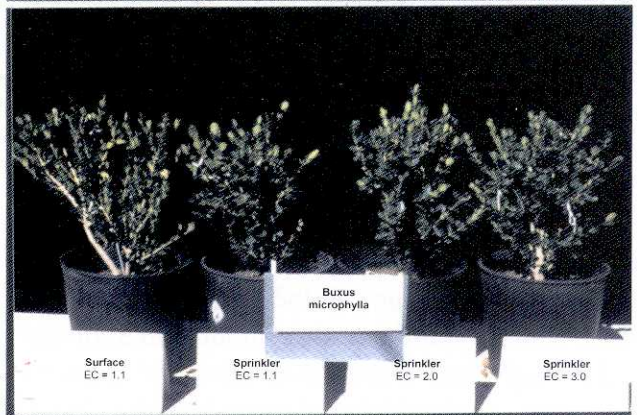
Photo Set 3. Shrubs, Low Profile

The tested shrub species generally grew slowly, but have shown higher levels of tolerance, except for Nandina plants (Photo Set 3). Rosemary plants, known for high tolerance to soil salinity, also suffered a significant growth reduction when sprinkler-irrigated at 2.0 dS m^{-1} . Euonymus, Hawthorne, Juniper, Cotoneaster, and Boxwood were more tolerant to salts, showing no or only a minor reduction in growth when sprinkled at 2.0 dS m^{-1} . Among the tall shrubs or tree species tested, Cottonwood suffered the greatest growth reduction due to sprinkler irrigation, followed by Photinia (Table 2). Shoot growth of other shrubs and/or tree species tested, except for Wax-leaf Ligustrum, was also deterred by sprinkling. Also note that the growth of Afghan Pines and Ligustrum was reduced without obvious leaf injuries (Photo Set 4).

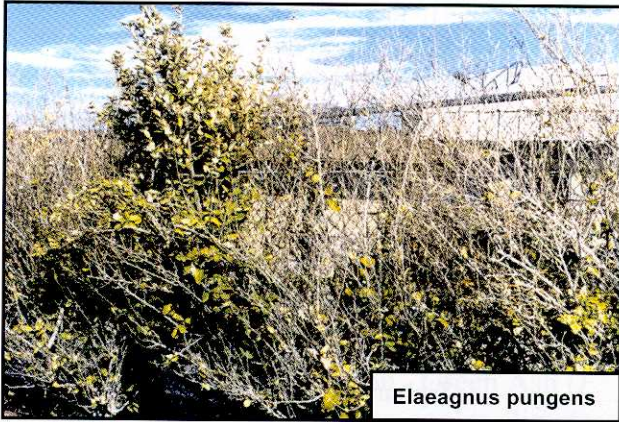
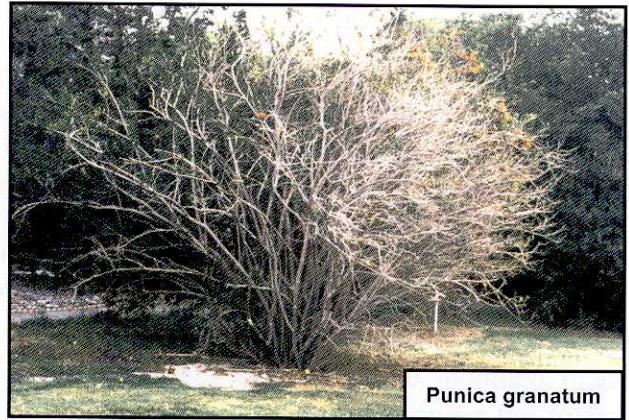
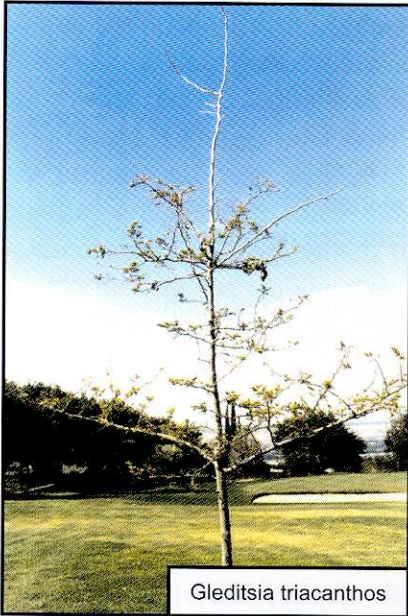
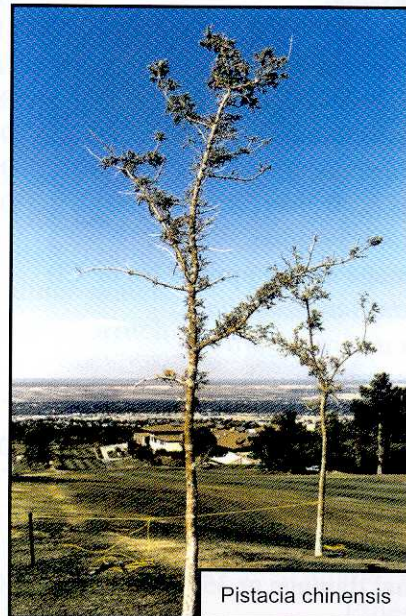
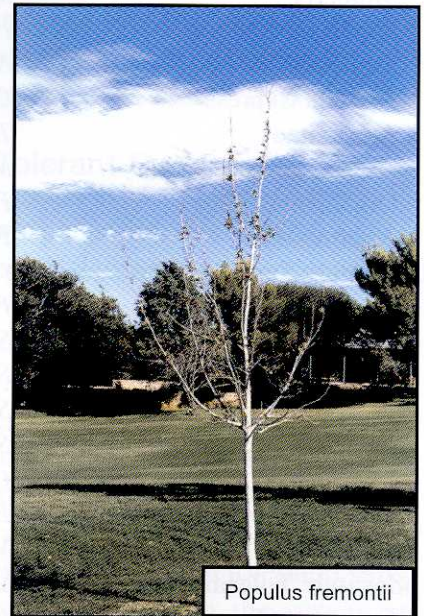
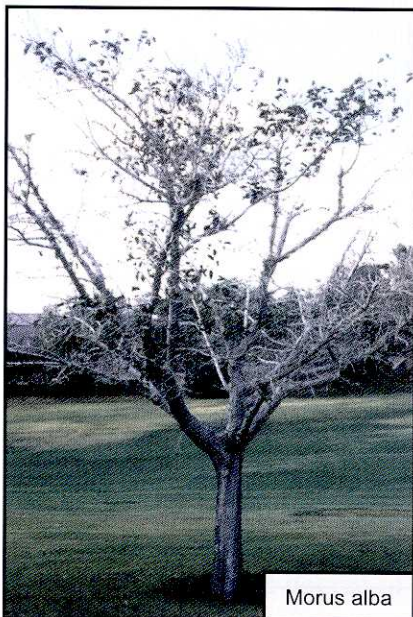
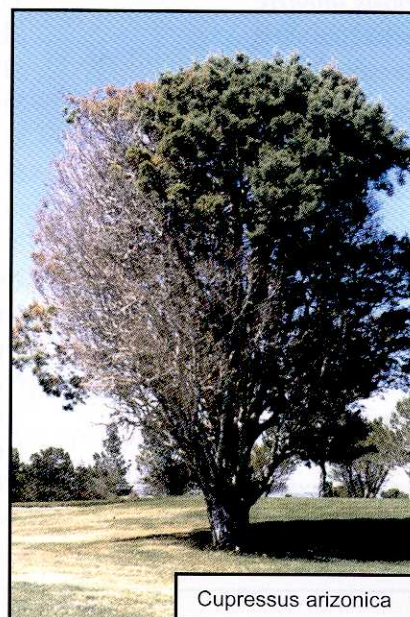
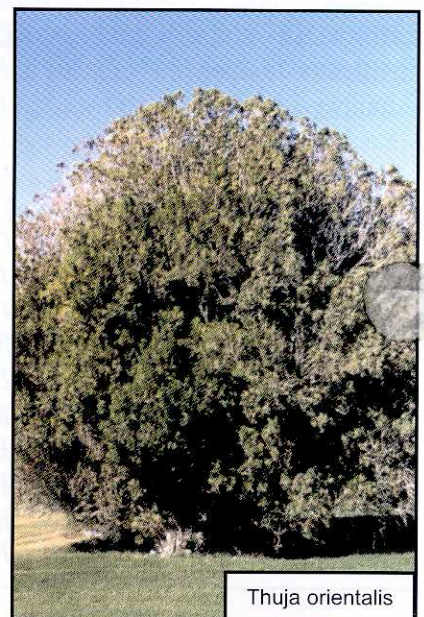
Photo Set 5. Sensitive Shrub or Tree Species

The plants under this category suffered severe salt damage when salinity increased to 1120 ppm (or Na and Cl concentrations reaching 300 to 350 ppm). Silverberry and Pomegranate were in this category, and both suffered severe defoliation (Photo Set 5). Pomegranate is among the most tolerant fruit trees against soil salinity. Silverberry leaves have the water-adsorptive surface beneath their leaves (Photo Set 8b). Many deciduous trees, including Honey Locust, Black Locust, Chinese Pistache, Bur Oak, Red Oak, Mulberry, and Poplar are also prone to foliar salt damage (Photo Set 5). These species, except for Poplar are known to be tolerant to soil salinity. Salts are retained readily on these leaves, and are presumably adsorbed into the leaves (Photo Set 8c and 8d). Other salt-sensitive deciduous trees or shrubs include Osage Orange, Mimosa, and Ornamental Pears, all of which suffered extensive defoliation.

Arizona Cypress is among the most salt sensitive *Cupressus* (Photo Set 5). This specie has the leaf structure on which salts tend to accumulate between scales more so than on the scales (Photo Set 8f). It is possible that the wettability is higher between the scales than at the hump of the scales. Arborvitaes, both American and Oriental species, are also salt-sensitive, and have the leaf structure similar to Arizona Cypress, but it is tender and lacks hard scales.

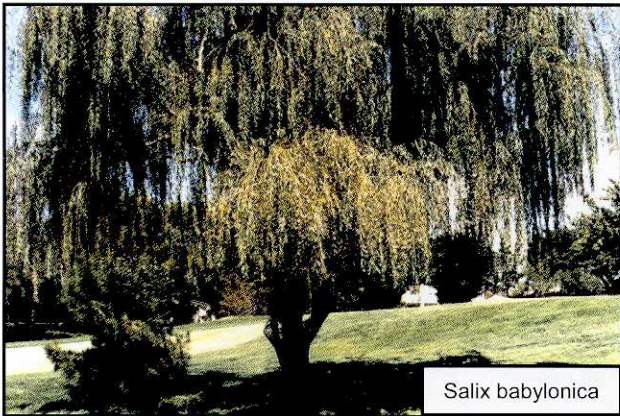
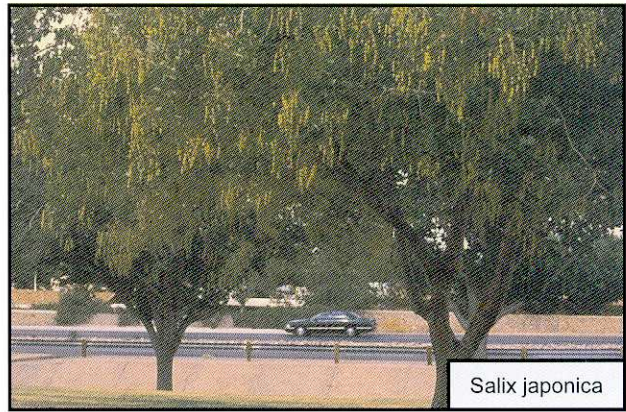
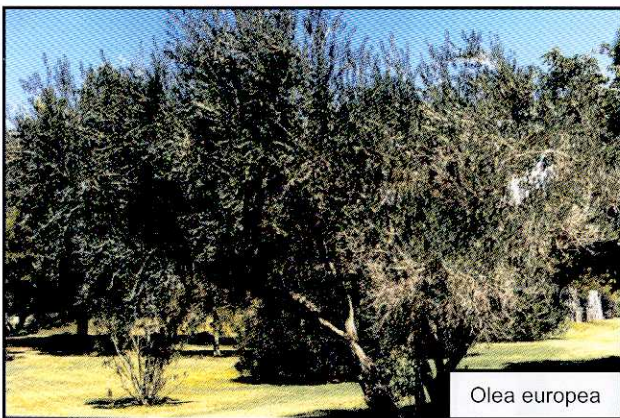
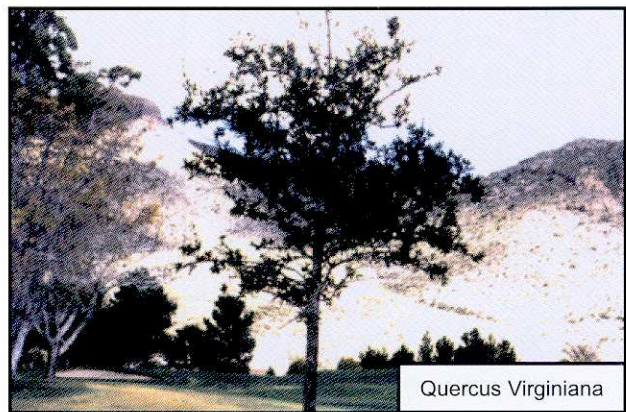
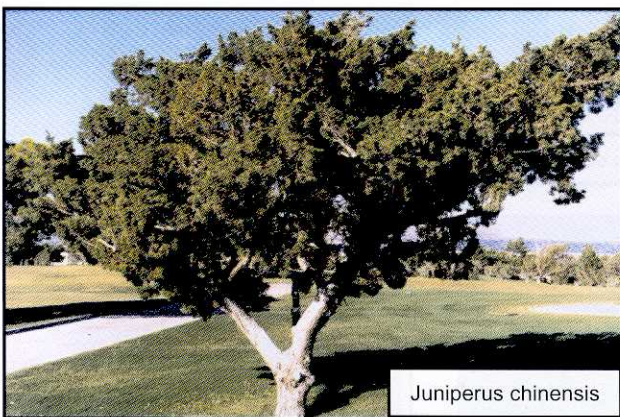
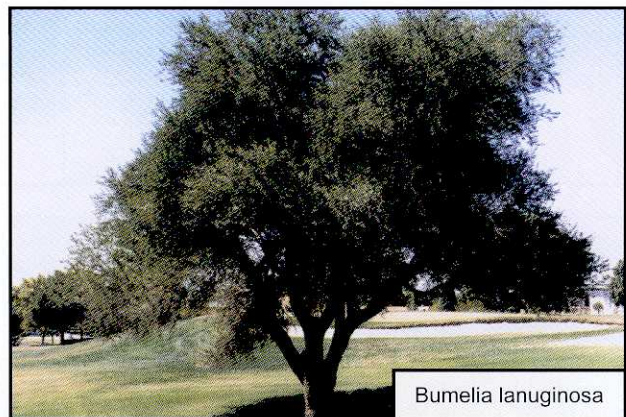
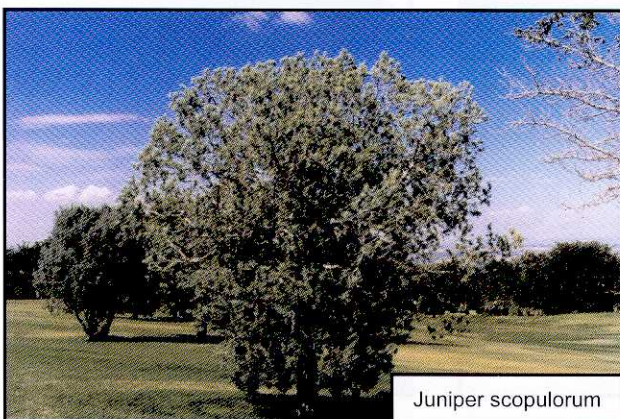
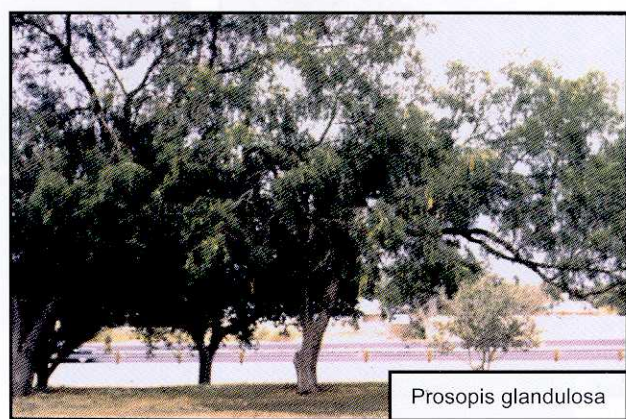
Photo Set 6. Moderately Sensitive to Moderately Tolerant Species.

Japanese Pagoda Tree (*Sophora japonica*) is an ornamental tree. The leaves of this tree had extensive tip-burn, but with minimal defoliation. The lower branches of Chittamwood (*Bumelia lanuginosa*) defoliated when hit by sprinkler streams (Photo Set 6). Live Oaks sustained moderate damage. The young oak tree shown in Photo Set 6 is Southern Live Oak, and has sustained a considerable degree of defoliation.

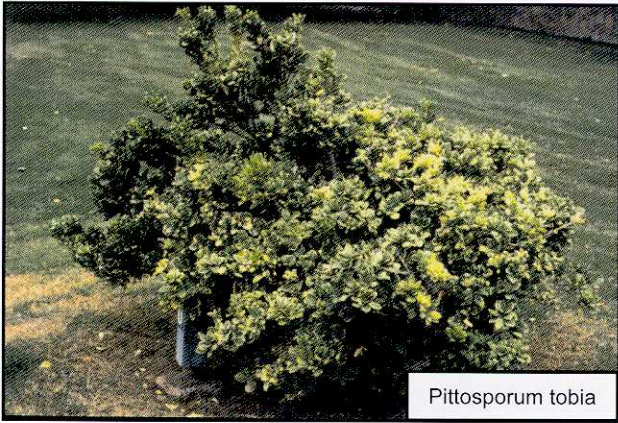
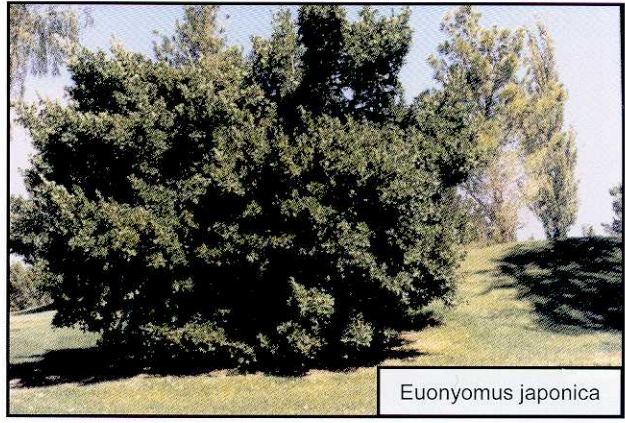
Photo Set 7. Tolerant Species.

The plants under this category have shown no recognizable salt damage when irrigated with the saline water containing 1120 ppm of dissolved salts at a Na concentration of 350 ppm, and include Italian Cypress, and Hollywood Juniper (Photo Set 7). These species have scaley leaves, and salts tend to accumulate on the ridge of the scales (Photo Set 7). Pittosporum, Oleanda, Ligustrum and Euonyomus, all of which have leathery leaves, are also among a few species which tolerated salts.

Pines widely planted in the survey area include Afghan (or Mondale), Aleppo, Japanese Black, Italian Stone, and Pinon. All of these species are tolerant to salts (Photo Set 7). Salts are deposited on the ridge of the needle-shaped leaves (Photo Set 8h), but not into the low-lying seams where stomata are present.

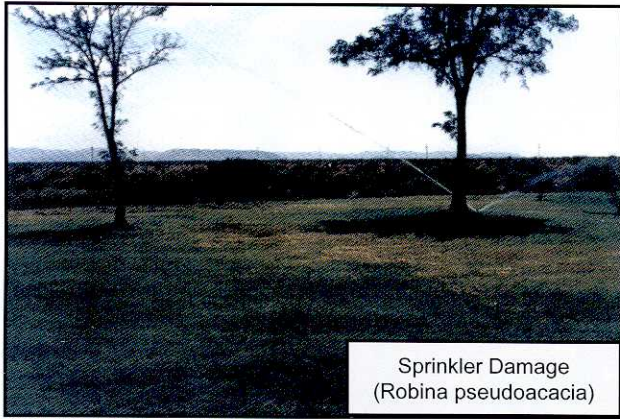
Sprinkler Damage
(Robinia pseudoacacia)

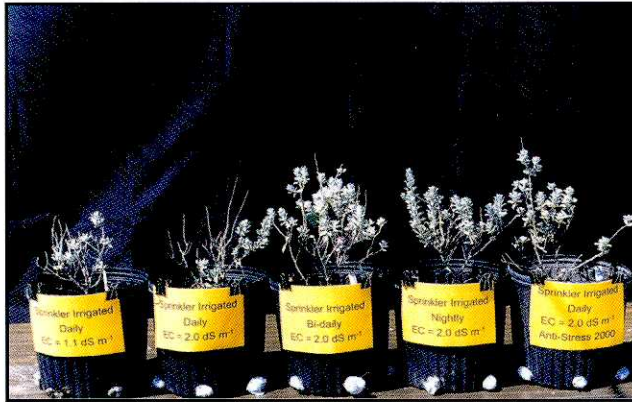
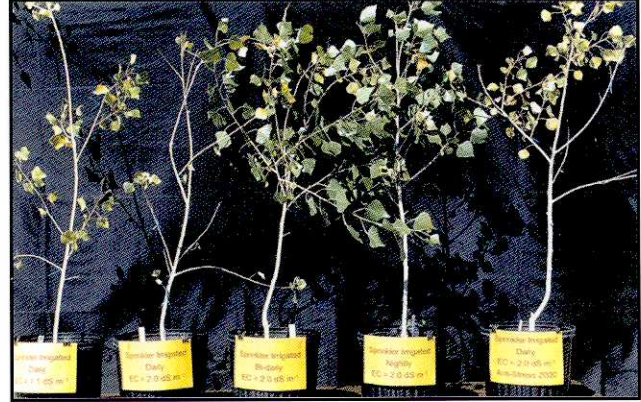
Photo Set 10. Irrigation Management on Salt Damage.

Results have shown that reducing irrigation from daily to every other day can reduce leaf damage in some plants, such as Cottonwood, Texas Sage, and Lantana, but not Liriope which is sensitive to soil salinity (Photo Set 10). In this experiment, the quantity of water sprinkled per application was kept the same for daily or every other day irrigation, thus presumably yielding the same level of salt washing from the leaves. The primary difference was the frequency of wetting which triggers salt adsorption into the leaves. Other studies (e.g., Maas et al., 1982) also indicate that salt damage decreases with decreasing frequency of irrigation.

Leaf damage was also found recognizably less in plants irrigated during night hours when stomata is closed (photo set 10) . Other studies also indicated that night irrigation reduces foliar salt damage (Busch and Turner, 1967). One of the

chemicals tested made leaves less wettable, and has reduced salt injury. However, the leaves sprayed with anti-transpirants became yellow and many have eventually defoliated (Photo Set 10), presumably due to heat damage associated with stomata closure or leaf coating.
