GENERAL SETTING

PHYSICAL SETTING

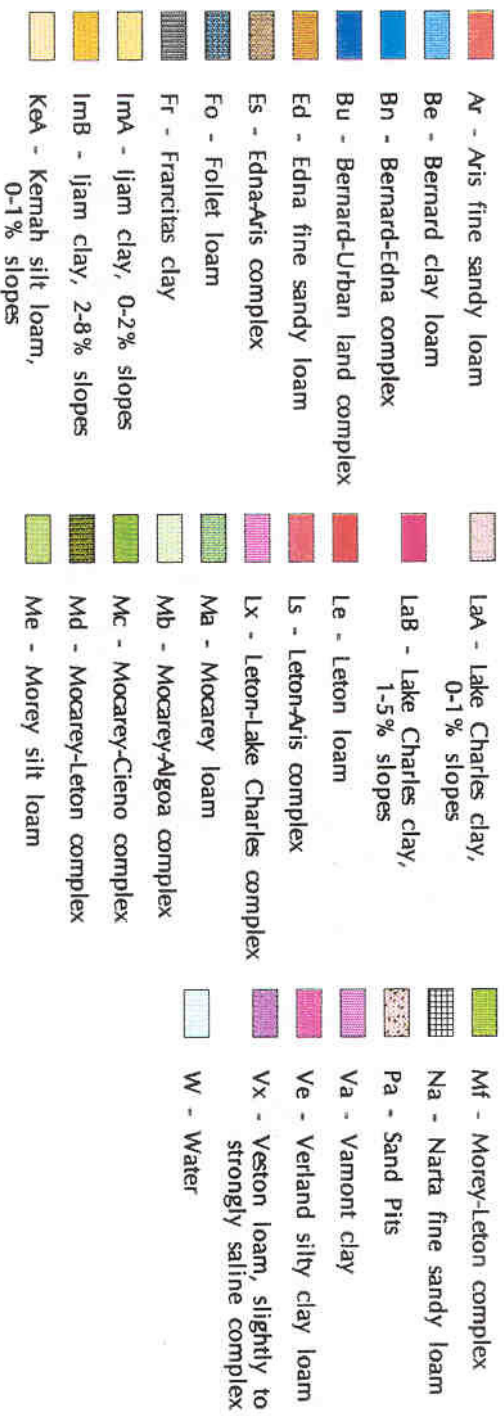
Figure 4. Soils of the Dickinson Bayou Watershed

Soils north of Dickinson Bay and in the Dickinson Bayou watershed are defined by the Soil Conservation Service as nearly level, somewhat poorly drained, nonsaline, loamy soils with a clayey subsoil (Crenwelge et al., 1988) (fig. 4). The major soil series associated with these areas are the Lake Charles-Bacliff, Bernard-Verland, and the Kemah-Edna-Leton. These soils are primarily prairie soils, with forested soils along the bayou and creeks. The major soils south of Dickinson Bay are deep, saline soils of the marshland that are somewhat or very poorly drained and have a loamy or clayey surface layer. Major soil series found in these areas are the Narta-Francitas and the Ijam. Hydric soils in the Dickinson Bay and Bayou area are Leton loam, Bacliff clay, Ijam, Harris clay, Veston loam, Narta loam, and Francitas clay.
