Foliar Salt Damage of Landscape Plants Induced by Sprinkler Irrigation

S. Miyamoto
and
John M. White

Synopsis

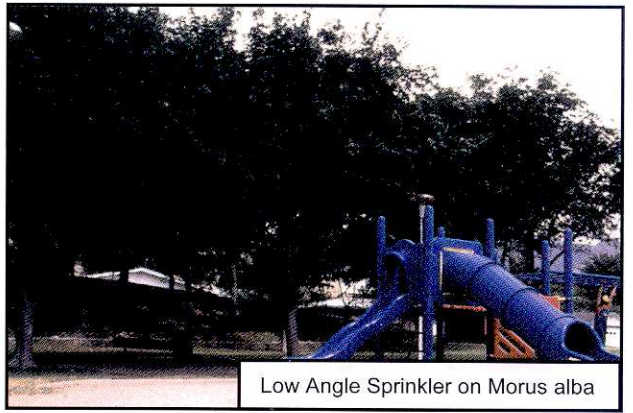
Low Angle Sprinkler on Morus alba
